## Thermal imaging inspections help optimize steam transport at Royal Vopak

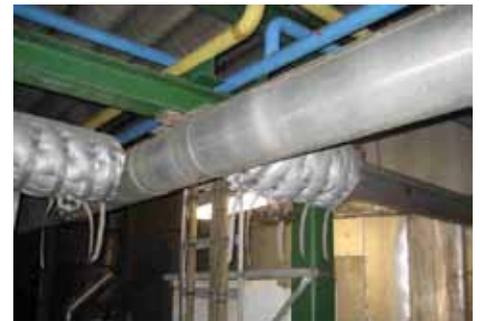
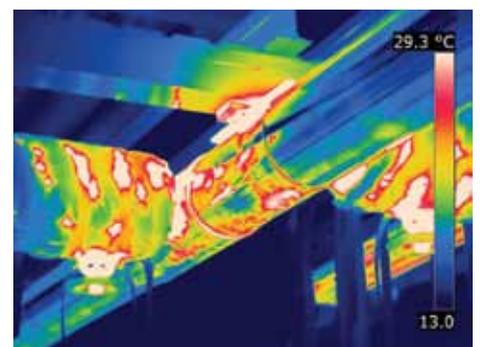
*Heat leakage due to failing insulation clearly shows up on the thermal image.*

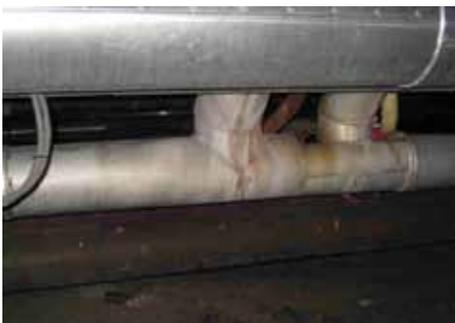
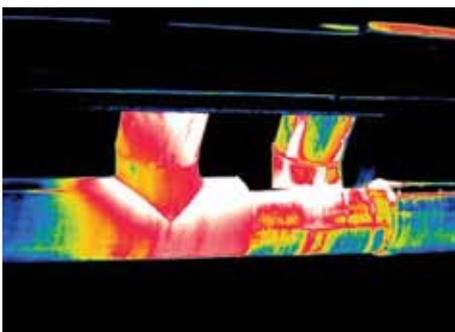
*Emissivity and infrared reflection made it an interesting challenge for Grispen to provide the level of accuracy needed for the energy loss calculation.*

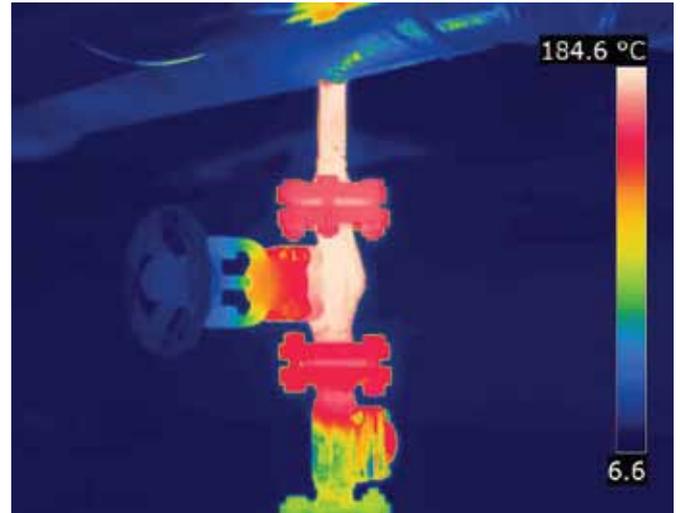
*The inspection revealed about 150 problem areas that were extensively documented using the highly accurate FLIR P660 thermal imaging camera.*

Together with Grispen and his colleagues Vallen spent several nights at the terminal, looking for problem areas. "We found about 150 sites that warranted further investigation. The analysis is not completely finished yet, but I can reveal that in several locations the insulation defects can be called severe. To put it in some kind of perspective: in several of these 150 locations the financial effect of the energy loss is similar to tossing one or more high quality flat-screen televisions in the trash each year."

With the information from Vallen's calculations Hoogstrate can accurately determine the cost of each problem area and, combined with a repairs quotation from an insulation specialist, he can then immediately see whether repairing the insulation in that particular location is worth his while. According to Grispen this would not have been possible without the extremely accurate FLIR P660 thermal imaging camera and the extensive training FLIR Systems provided. "There simply is no other thermal imaging camera supplier that provides the same level of service and product quality as FLIR Systems", Grispen concludes.
