Technical Note

Performance Optimization Techniques for Rooftop HVAC Equipment

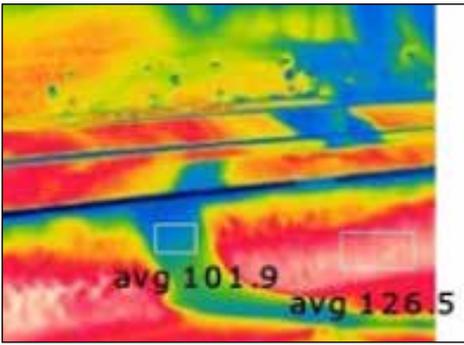
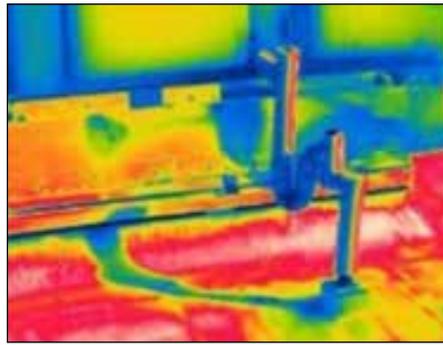
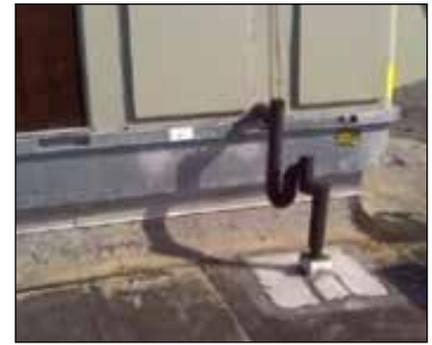
Figure 1: Three images of an RTU curb connection: Left - close-up IR; Center - zoomed out IR; Right - visible.

To demonstrate how all of these elements can impact the interpretation of thermal images, consider the IR and visible images of a typical RTU in Figure 1. In the photo on the left, an abnormal temperature distribution is discovered in the form of a cold streak down the vertical face of the curb. When you stand farther back, the center image shows this is actually just a shadow cast by the condensate riser. The visible image on the right confirms the source is truly a shadow, and thus, there is no problem. Taking the average temperature in an area, in the left image we see that the shadow is cooler than the rest of the roof deck by about 25°F. Another tip is that as you rotate around, the cold streak does not move, but rather stays in the same location, confirming that the roof deck in that area is genuinely cooler and the streak is not a reflection. Also, this condensate piping is wrapped with black elastomeric insulation, thus no significant reflections would be expected.

Next, looking at the curb, you see that the IR patterns are abrupt and chaotic, which is characteristic of this shiny, unpainted metal. On the painted RTU itself, the temperatures are more reliable. You could either ignore the curb readings or apply electrical tape if you desire a realistic temperature.

Finally, if you focus on the non-shadowed roof deck, you will note that it is a mostly uniform temperature that mildly cools as it rises up the curb and reaches vertical, thus changing angle relative to the sun. You can also note differences in the exposed roofing materials (dirty vs clean areas, tar, patches of different materials, etc.). These are more easily identified if visible images are captured simultaneously.

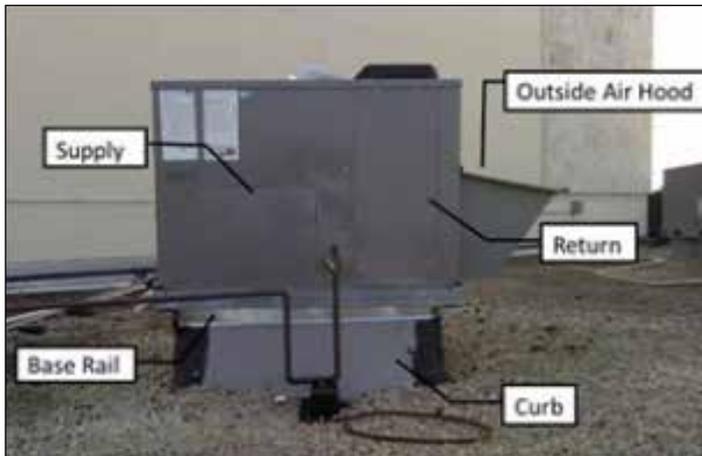
Figure 2 shows visible and thermal images of a supply air duct leak at a packaged rooftop air conditioning unit (RTU). This unit serves a mall retail tenant who had been experiencing cooling problems since the original installation about 6 months prior. The tenant's construction team had determined that the RTU was undersized and was planning to replace it with a larger unit. Our thermal survey quickly revealed that the primary culprit was actually poor duct connections and a break in the gasket between the RTU and the curb. The result was that much of the supply air was leaking out to the roof deck rather than cooling the tenant space.

Figure 2: Visible photograph of a packaged RTU serving a retail tenant, with major components labeled (left) and a close-up of the center area, with a superimposed IR image revealing a distinct air leak (right).

The thermal image in Figure 2 shows a clear gradient with the coldest portion at the compromised area of the gasket, and gradually warming in a radial pattern as you get farther from the supply air leak. Note that the IR camera does not see the 55°F supply air leak directly but instead sees the effect of the cold air impinging on the roofing over the curb. Running our

We have found that picture-in-picture (superimposed) deliverables with a rainbow color palette are more readily understood by nontechnical clients – blue is cold, red is hot, and the problem area is isolated on top of a visible picture for clarity. When incorporated correctly, the IR image adds a clear empirical component to the reports and streamlines future discussions and actions. Providing the conclusive image in Figure 2 to the tenant resulted in the installing contractors immediately repairing the installation errors at no additional cost. This was a net savings of approximately \$7,500 from their originally requested upgrade fee. The tenant's space is now cooling properly with no known reported issues since the repair.

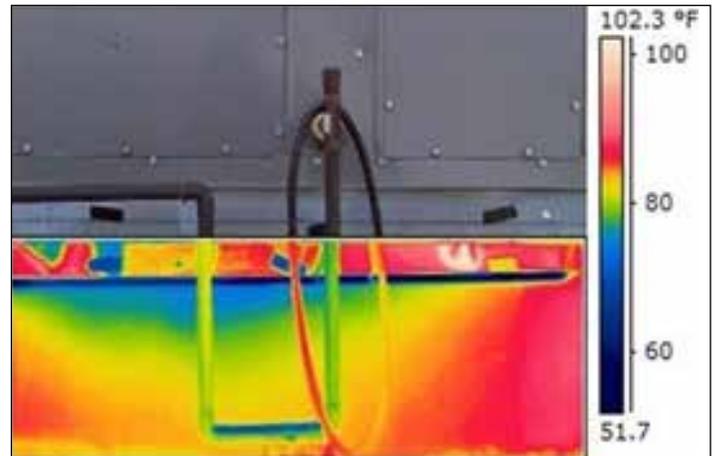
hand along this area we were able to confirm the leak. To highlight the value of relative temperature relationships over highly accurate absolute temperatures, Figure 3 shows the full uncropped IR image used in Figure 2. If we assume that the RTU housing, roofing over the curb, and the tar patch are all $\epsilon=0.95$ (left) versus $\epsilon=0.85$ (right), the absolute difference is 1°F- 20°F. The difference is in the higher range for the RTU housing and tar, which is expected since their real emissivity values are slightly lower than the roofing here. But for our intended purposes, these differences are trivial, and the emissivity setting does not affect the displayed IR image if you set the temperature range to auto-adjust. You should obviously estimate the emissivity within reason, however,

since $\epsilon=0.05$ for the above example would have given nonsensical readings of 175°F-310°F. In general we simply ignore the flashing from our analysis due to its low emissivity, but you can note the three electrical tape strips we placed there to demonstrate its true temperature pattern versus the reflections.

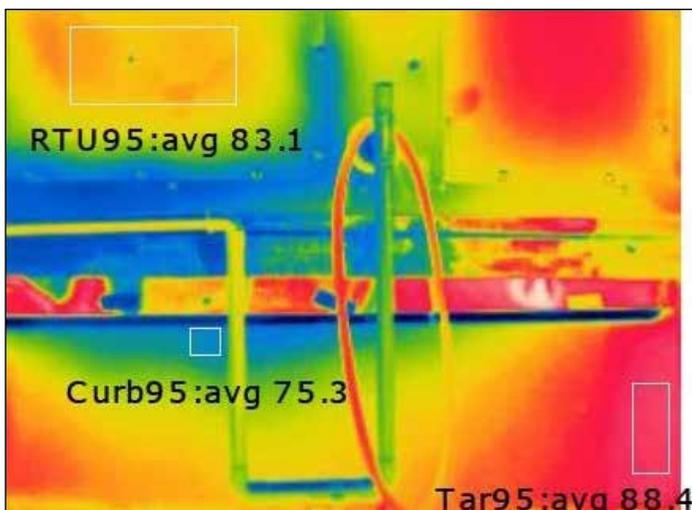
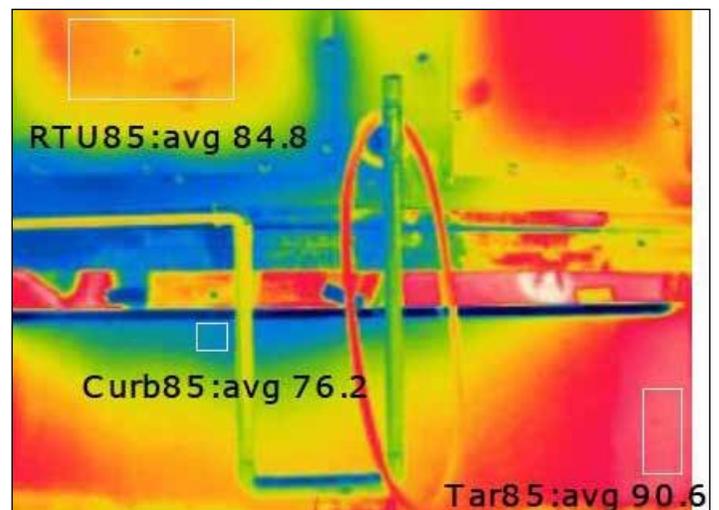
Figure 3: The same IR image from Figure 2, with "default" overall $\epsilon=0.95$ (left); and adjusted $\epsilon=0.85$ (right).

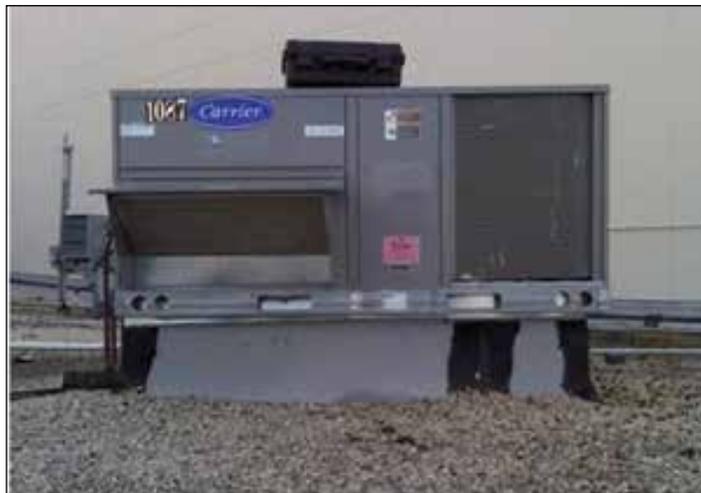
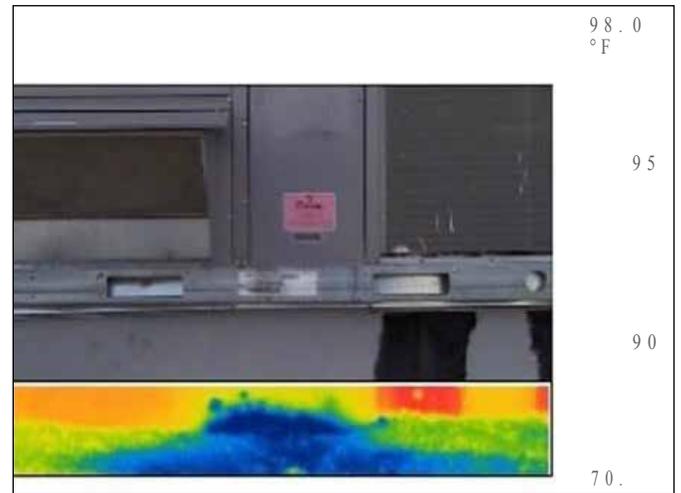
Because the supply air duct connection was not properly installed on this unit, the air leak was blowing directly on the inside of the insulated curb as well. The curb's exterior surface temperature dropped to around 70°F as shown in Figure 4, which is well below local outdoor dew point and was saturating the roof deck and occasionally dripping indoors. The excess air was subsequently leaking out where the curb gasket had been compromised as shown previously. No condensation would be expected back on the leak in Figure 2 because the "local" dew point at that area would be the conditioned supply air itself, rather than the humid outdoor air. Also note that the supply air temperature itself was around 55°F. The warmer temperatures displayed in these examples are due to curb conduction and outdoor radiant loads.

Figure 4: Visible photograph of the same packaged RTU, front view (left) and a close-up of the center area, with a superimposed IR image revealing excessive sweating (right).

Note that if the return duct connection had an equally significant leak, it would not be as directly obvious because it would be drawing outdoor air into the curb, thus not creating a ΔT from this view. For this reason, be aware of the ambient and reflected temperatures relative to the process fluids you are measuring.

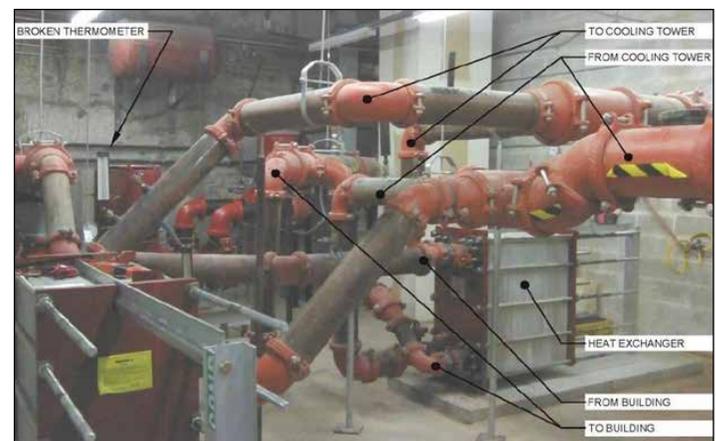
The pumps and heat exchangers are typically in a room at the roof deck adjacent to the cooling tower, as shown in Figure 5. Many WSHPs in this building would continually trip off on safety, especially near midday on weekends (peak occupancy and peak solar heat gain). That indicates that the closed loop water into the building was reaching upwards of 100°F, instead of the 87°F typical maximum design.

Figure 5: Visible photograph of a rooftop mechanical room with pumps, piping, and heat exchangers.

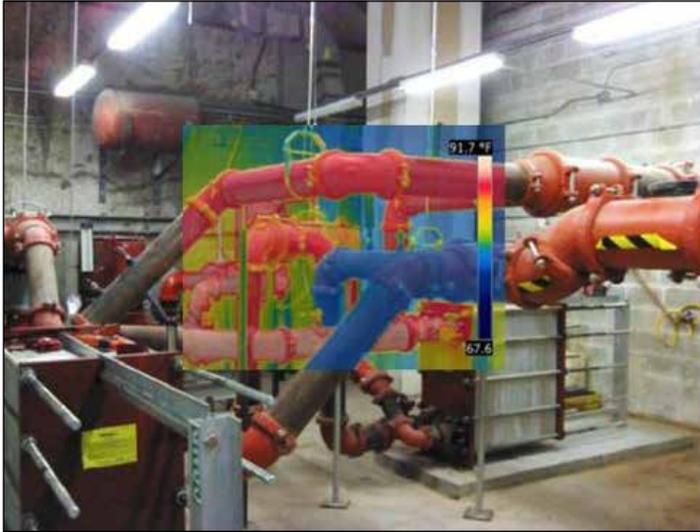
Figure 6 shows the mechanical room with a superimposed thermogram and the adjacent table shows the pipe surface temperatures using the average within an area. The abnormal temperatures (open loop is more than five times the ΔT of the closed loop) indicate restricted flow across the heat exchanger. The pressure drop across the pumps confirmed restricted flow. Excessive debris in both loops from poor maintenance had clogged the small channels in the heat exchanger and rendered it ineffective. An alternate contractor was requested to perform a chemical cleaning and flushing on the two loops. Within five minutes of cleaning the two loops, the system temperatures equalized and have been running trouble-free ever since.

Figure 6: Same as Figure 5, with a superimposed IR photo showing relative condenser water piping temperatures.

Pipe Description	Average Pipe Surface Temperature		
	From	To	Delta T
Cooling Tower	77.0°F	88.1°F	11.1°F
Building	89.5°F	87.4°F	2.1°F

The emissivity of the painted piping is near $\epsilon=0.85$ and there is no pipe insulation (other than the minor resistance of the steel piping itself). Thus, temperature readings captured with the IR camera are reasonably accurate and equal to the fluid temperature. The IR survey correctly and rapidly identified the root cause, and provided empirical evidence to the ownership and maintenance personnel.

The original contractor had provided calculations incorrectly showing that the closed loop pump capacities should be increased. The owner sought a second opinion. Using thermography reduced our labor in the field and saved the owner approximately \$50,000 by not changing the pumps.
