## BP CHEMICALS ENHANCES SITE SAFETY WITH FLIR INFRARED

**In the production of acetic acid BP Chemicals is world renowned and responsible for a significant proportion of world capacity. Its proprietary methanol carbonylation technology, Cativa, is in demand globally and in particular in Asia where the company continues to establish new manufacturing partnerships. In the UK its site at Saltend in East Yorkshire is not only a manufacturing flagship but also a major centre for ongoing research and development of the process.**

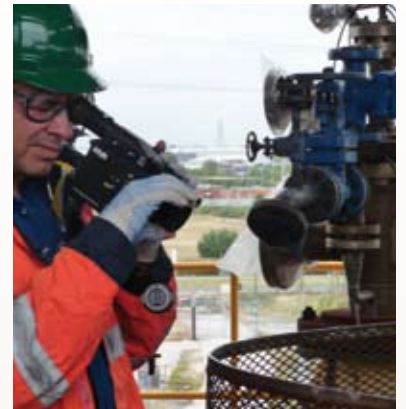
*Dave Fashimpaur from BP is checking for leaks of natural gas using his GasFindIR HSX*

Bought in 2005, the FLIR GasFindIR camera has been central to Dave Fashimpaur's troubleshooting work and it now accompanies him all over the world. He added, "There's no set-up involved. When you switch the camera on it has to cool down to the required temperature but after that you get your images immediately. There's no post processing involved and I just play the video footage back via Windows Media Player." The camera allows him to inspect wide areas efficiently and to pinpoint the source of the leak. "I'm looking for motion in the black and white image," he continued. "Of course that could be steam or metal tags waving in the breeze so my judgement is informed by experience but by changing the lens I can capture the complete scene or a small detail." The 25mm lens is the most popular but Dave also has 50mm and 100mm for longer range inspection.

This FLIR GasFindIR™ HSX camera is designed for outdoor use. For that purpose it comes complete with selectable frame acquisition rates to suit the ambient temperature. Too great a heat results in a saturated image and too cold, insufficient detail. This feature ensures optimum performance whatever the ambient temperature so that the GasFindIR can be used with equal efficiency for inspecting hot compressors or sites characterised by permanent ice.

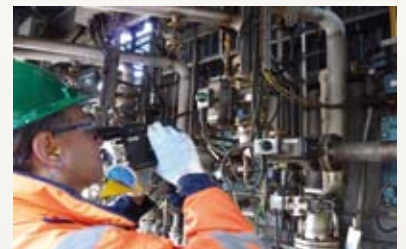
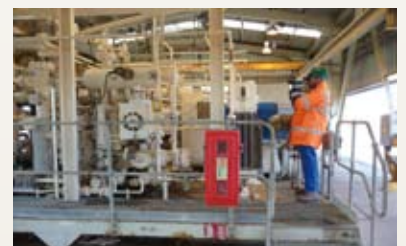
*Using GasFindIR HSX to check for natural gasleaks*

cameras recently employed to check plant integrity at the Saltend site. Dave Fashimpaur used his HSX model to detect a range of gases including methane and methanol that are both predominant at the UK plant; HSX is able to detect 20 different gases in total. In addition, a long wave version of the camera was used that is capable of detecting acetic acid, acetic anhydride and ammonia, three of the total of eight products processed at Saltend.

able to trace the source of an odour at a condensate sump and small leaks around compressor flange plates.

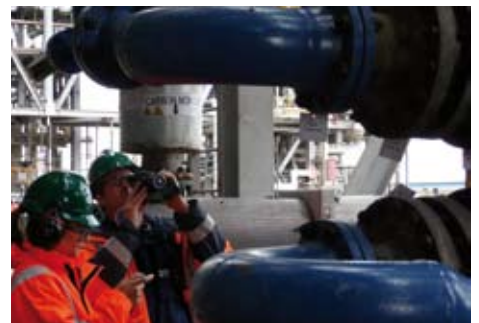
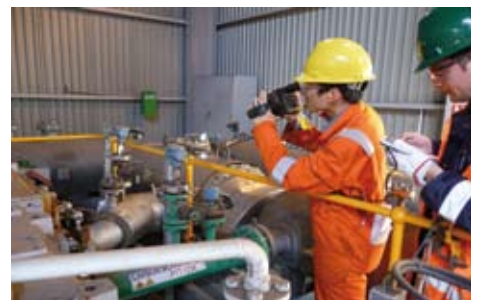
*In both pictures CO leaks were found with the GasFindIR CO*

Unlike other gases at Saltend CO doesn't have the advantage of odour and therefore unless the emission exceeds the alarm setting of a personal monitor or a fixed detector, a leak will remain undetected. The first small escapes that the FLIR GasFindIR CO camera found were from an infeed pipe and a heat exchanger flange, both part of an electrically driven compressor. From a gantry in an adjoining covered section of the plant, the camera was then used to inspect a series of steam driven compressors. Two further CO leaks were found. In high sensitivity mode both were clearly visible as plumes of gas. "These were great examples of small and easily fixable leaks that the camera picked up speedily and at a safe distance," Geoff Wilcox explained. The FLIR GasFindIR LW proved equally effective. This camera was primarily developed for the detection of the greenhouse gas, sulphur hexafluoride (SF6), but its wider capabilities made it a good choice for BP. It can also 'see' acetic acid and therefore provided clear images of small emissions from the vapour space in tankers and from a vent in the roof of the loading bay. It also identified small escapes from automatic loading arms whose emissions are largely controlled by recovery systems. Ammonia is another gas detectable by this LW camera and this was seen in a vent situated 20m above ground level with the camera position at a distance of 150m or so.
