FLIR B-Series infrared camera tells truth about walls and facades

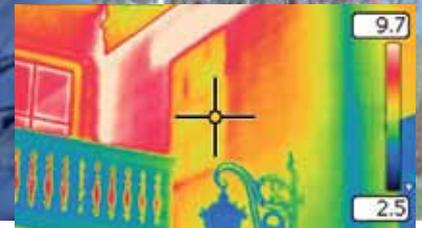
A former window - closed with bricks or plaster of a better quality

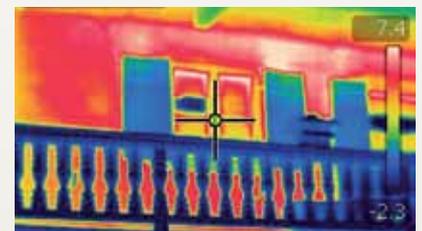
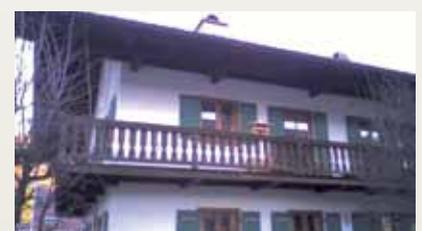
Bad insulation above balcony window
