STRUCTURAL SURVEY POST-EARTHQUAKE AIDED BY IR THERMOGRAPHY APPLIED TO CULTURAL HERITAGE

The earthquake happened in Abruzzo (Italy) April the 6th, 2009 killed about 300 people. Furthermore, many works of art have been almost destroyed or are in a great danger of collapse. Monuments carrying centuries of history, important buildings, like Churches, palaces or castles, in the city of Aquila or smaller villages nearby needs to be quickly restored, but first of all checked. Unfortunately, not only human beings, but even precious frescoes must be evaluated in order to be saved. The emergency needs fast, safe, reliable tools.

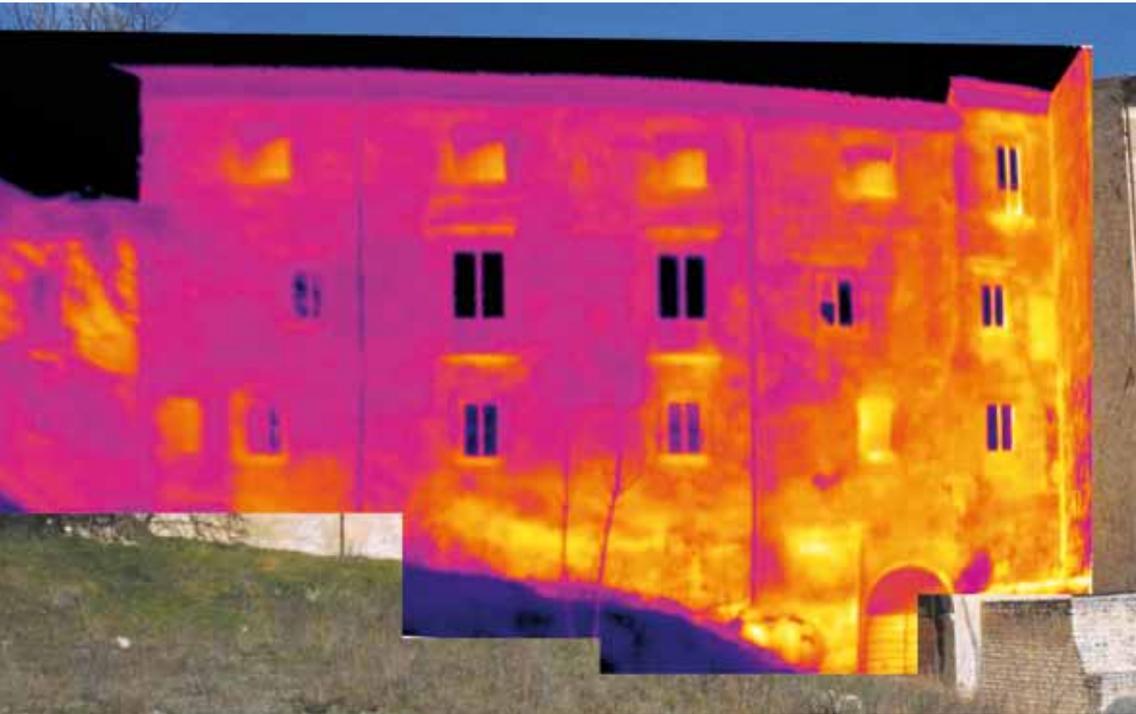
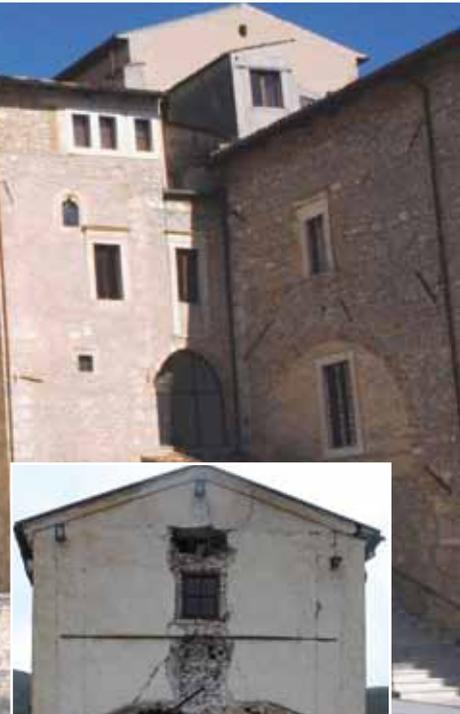
IR thermography has been found very valuable for this purpose, due to its optical nature. Fortunately, the CNR-ITC set up robust techniques for the non-destructive testing and evaluation, since a long time ago. For instance, the S. Lucia abbey has been monitored last April 26th to evaluate the structural conditions of the wall and the fresco itself (Giotto's school XIV century). The picture clearly shows many structural cracks and the lack of adhesion. It is worth saying the new transient technique adopted required just 3 hours to monitor the whole buildings and the processing of hundreds of thermograms has been carried out using other 3 hours. After that, the day after the authority decided the best emergency intervention to save the monument. The result has been achieved so promptly even because of the use of effective thermal cameras by FLIR Systems.

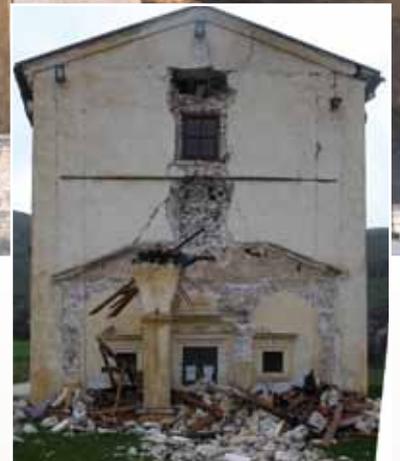
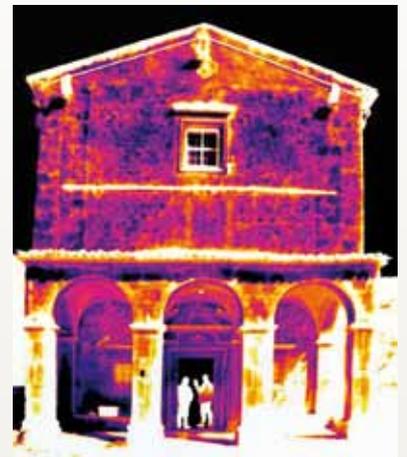
It is quite impressive to notice the correlation between week points enhanced by thermography before the earthquake and the collapsed parts. The following picture give another example taken from the church of S. Stefano in Sessanio (AQ, Italy) last year and today.

Picture of the S. Stefano di Sessanio (AQ) church, before and after the earthquake
