Automatic quality controls with FLIR A320 ensure that the cars produced at Ford Genk work perfectly

FLIR A-Series thermal imaging cameras: accurate, reliable and maintenance free

APPLICATION STORY

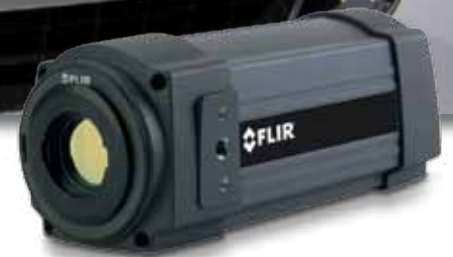
The FLIR A320 is an affordable and accurate non-contact temperature imaging and measurement tool.

The thermal imaging camera Arthur Knuyesen has chosen to perform these quality tests is the FLIR A320. The FLIR A320 thermal imaging camera offers an affordable and accurate temperature measurement solution with clever built in features like analysis, alarm functionality and autonomous communication using standard protocols. The FLIR A320 camera also has all necessary features and functions to build distributed single- or multi-camera solutions utilizing standard Ethernet hardware and software protocols.

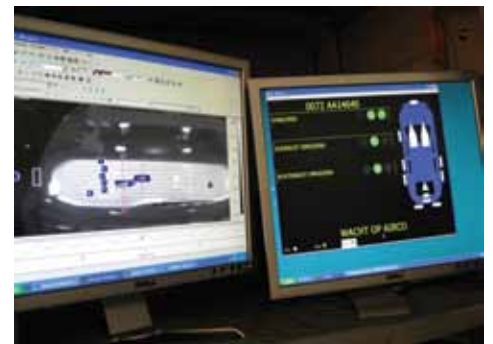
The programmable logic controller (PLC) compares the measurement data from the thermal imaging cameras with previously defined parameters.

The measurement data collected by the thermal imaging cameras are sent to the programmable logic controller (PLC), which compares the measured temperatures to previously determined parameters. If the recorded data is within those parameters then the car gets the green light to proceed. A screen next to the test site will display either a red or a green sign. If a red sign is shown the car must go to the repair department. If it is green the car can proceed to the next step in the testing range.

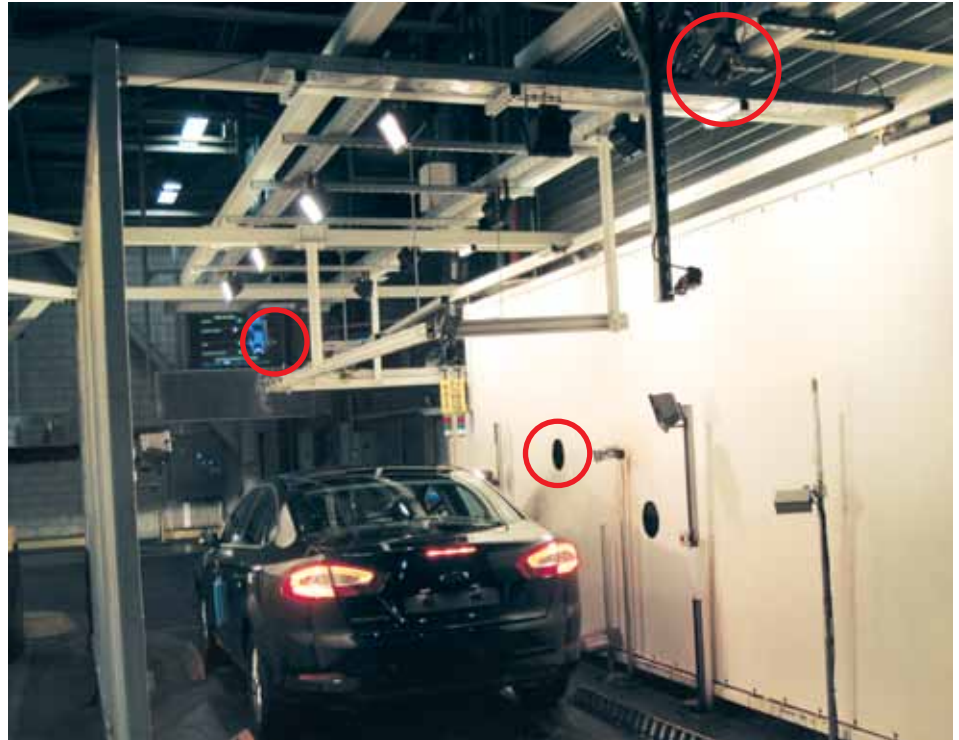
Ford Genk has three FLIR A320 thermal imaging cameras for testing the front window heating system, the rear window heating system and the air conditioning system. The locations of the thermal imaging cameras are marked in red.

"The three FLIR A320 thermal imaging cameras installed at Ford Genk test the

temperatures of front window heating elements, rear window heating elements and the air conditioning vent outlet", explains Knuyesen. "There's one mounted in the front of the car, pointed at the front window, another mounted behind the car to monitor the rear view window and the third is pointed at the window of the car door at the right hand side, to measure the temperature of the air conditioning vent output."

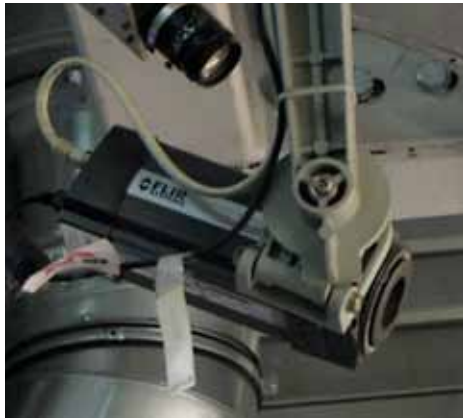
This FLIR A320 thermal imaging camera is used to check the front window heating system for defective heating elements.

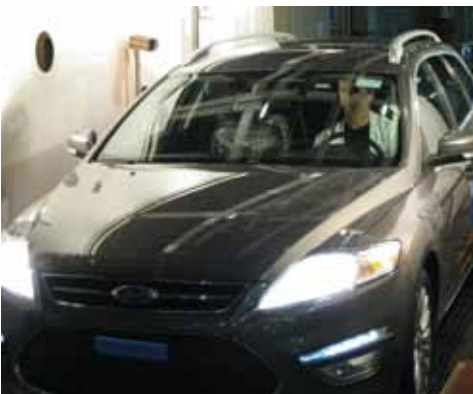
For each car model that has front window heating, the heating system is a bit different, that makes it difficult to test.

Ford is one of the few car manufacturers that produce cars with heated front windows. To make sure the driver’s vision isn’t obstructed by the heating elements the front window contains hundreds of little vertical heating elements instead of a few big horizontal ones. But according to Knuysen that made it difficult to set up a testing method. “For every type of car we produce here at Ford Genk the front window heating elements are a little bit different. Combined with the fact that the front window heating consists of many small heating elements this means that we cannot test the front window in the same method as we use for the rear window. That’s why we work with several square measurement areas. If any of those areas doesn’t heat up quickly enough the front window heating system is recorded as defective.”

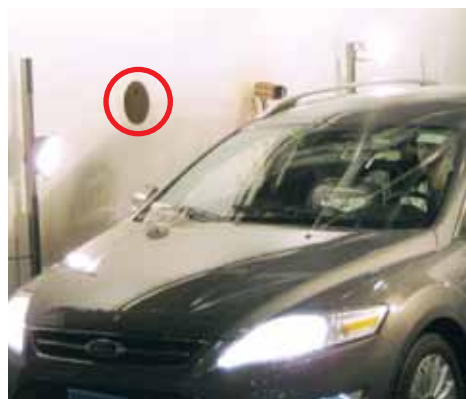
The thermal imaging camera behind the hole records the temperature of the air coming out of the air conditioning vent.

It started with the air conditioning test. "We were looking for a way to objectively test whether the air conditioning system was functioning properly, when we found that our colleagues at a Ford factory in Spain were using FLIR A-Series thermal imaging cameras for that purpose." To check the air conditioning system the test-driver opens the front right window and turns on the air conditioning at full power. The thermal imaging camera accurately records the temperature of the air emitted from the air conditioning vent and if the recorded temperatures deviate from the previously determined parameters it is sent for repair.

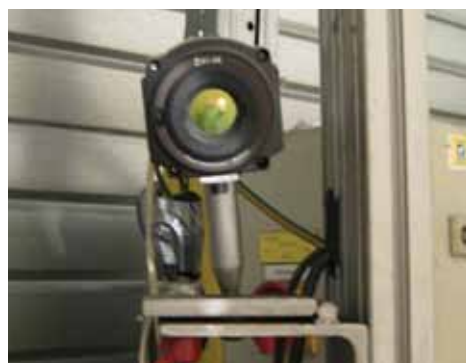
This FLIR A320 thermal imaging camera is used to check the air conditioning system.

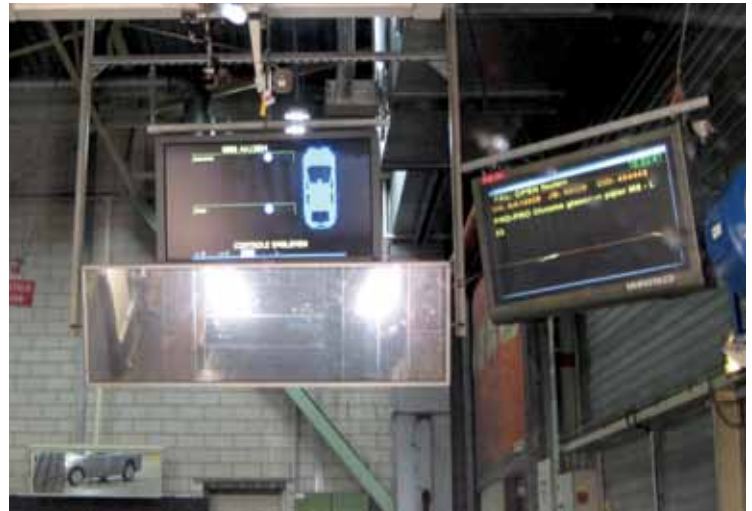
The screen next to the FLIR A320 thermal imaging camera that's pointed at the front shows the progress of the test.

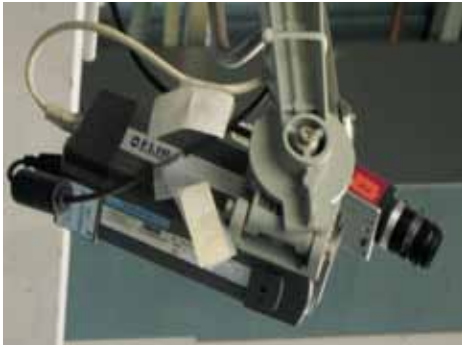
This FLIR A320 thermal imaging camera is used to check the rear window heating system for defective heating elements.

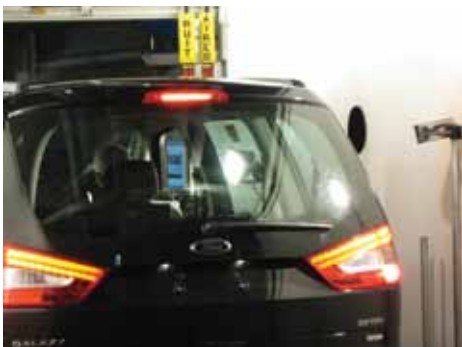
The test driver switches the rear heating elements on at full power.
