Thermal imaging helps Globus Baumarkt identify insulation problems

APPLICATION STORY

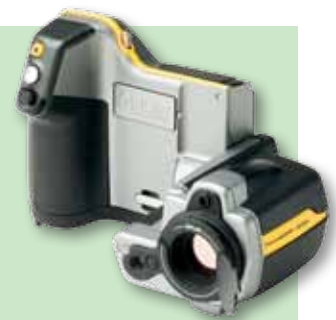
320x240 pixel resolution

Temperature range -20° C to 120° C

<50 mK sensitivity

Picture-in-picture

Humidity and insulation alarm

3.5" LCD touch screen

Integrated 3.1 Mpixel digital camera

Bluetooth connectivity with FLIR Meterlink™

Globus Baumarkt have both the FLIR B335 and the FLIR B365 thermal imaging cameras. The B-Series of portable thermal imaging cameras take ergonomics, weight and ease-of-use to a new level. Usability is key: FLIR has translated user feedback on comfort and clarity into a series of thermal imaging cameras that have comprehensive and innovative features, specially designed for building environments. The FLIR B335 and the FLIR B365 share the following features:
