Thermal imaging helps Globus Baumarkt identify insulation problems

APPLICATION STORY

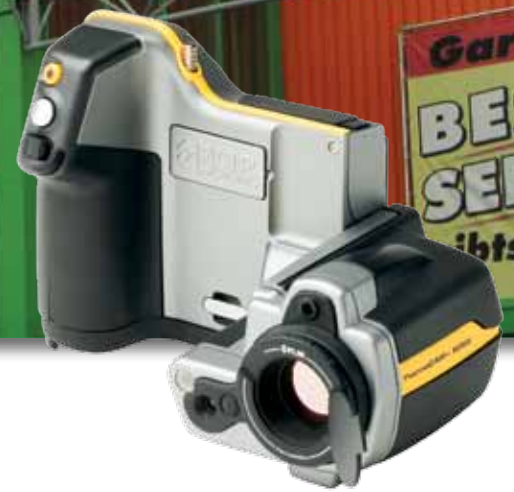
The B365 is smart, compact and powerful; a perfect tool for building inspection.
