## FLIR thermal imaging cameras provide solid proof for Italian court case

*One example is an Italian court case about moisture ingress and mold formation in a new apartment complex. The inhabitants claimed that the building construction was flawed, while the building contractor claimed that the inhabitants were to blame, because they did not heat and ventilate the apartments properly. Inspections with FLIR thermal imaging cameras brought the matter to a close.*

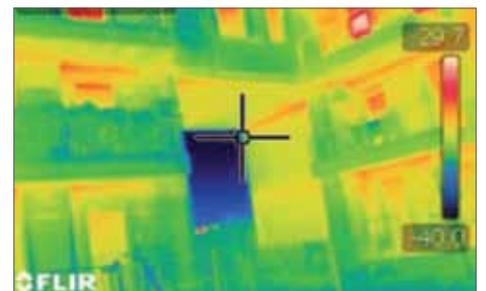
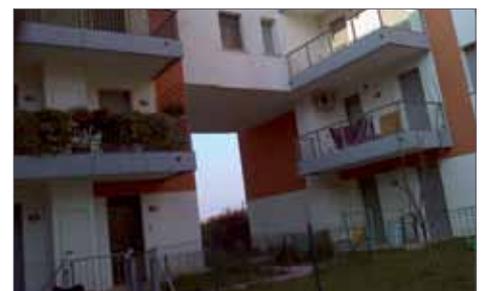
*This thermal image clearly shows heat leaking from the building.*

"We inspected the disputed apartments from both from the outside and the inside and we found some significant heat leakage and thermal bridges", explains Eviana Faccin, thermography consultant at Multites. "A thermal bridge is an area with less insulation. Heat follows the path of

the least resistance. Often heat will 'short circuit' through an element that has much higher conductivity than the surrounding material. This is called a thermal bridge. We found several of these thermal bridges in our inspections."
