Swedish hospital maintains heating and ventilation system with thermal imaging

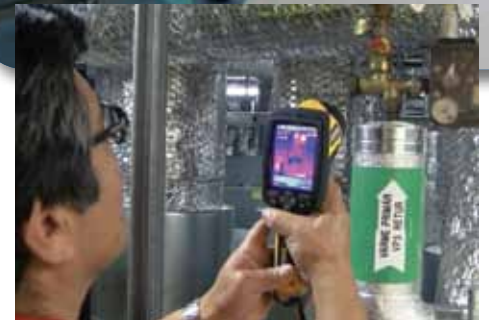
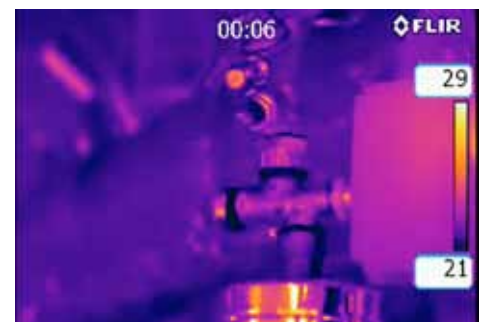
FLIR thermal imaging cameras can be used to detect a multitude of different heat related building issues.

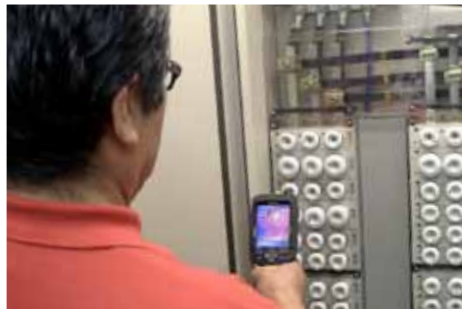
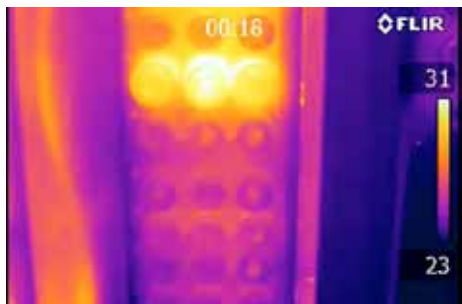
Where a spot pyrometer shows the temperature in one area, a thermal imaging camera can give an overview of an entire electrical cabinet, enabling quick and accurate faults detection.

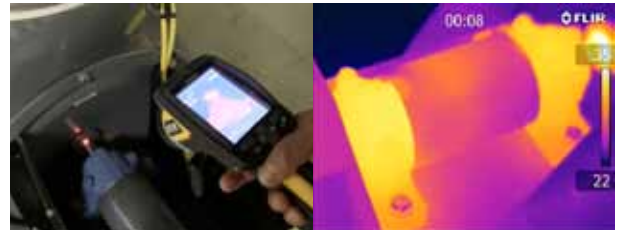
The thermal image shows mechanical components of an electromotor heating up due to friction.

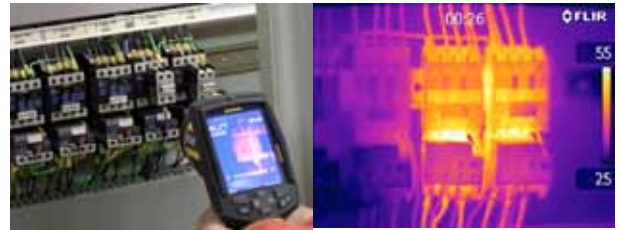
The thermal image clearly shows which fuses are too warm and will soon need to be replaced.

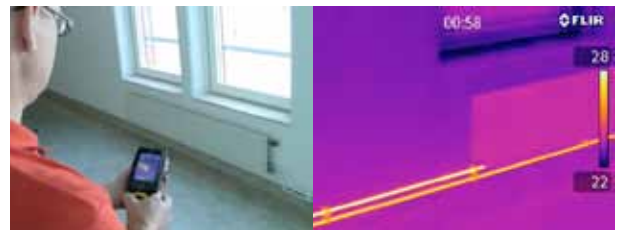
The radiator in the thermal image is clearly not functioning well. The hot water pipe is probably clogged.

Faults that the two technicians sometimes find in the hospital's HVAC system are clogged radiators or blocked ventilation ducts. "But there is much more we can do with the camera, such as inspecting fuse cabinets and mechanical components in the ventilation system for faults, checking whether the district heating shunt group is cooling the warm water down to the right temperature and even the backup batteries in the server room."
