Insulation of commercial walk in freezers checked with thermal imaging

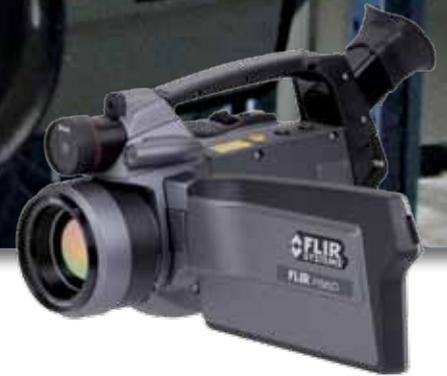
Highly sensitive, accurate and calibrated to -40°C the FLIR P640 thermal imaging is the perfect tool for freezer insulation inspections.

Another important thermal imaging camera feature for this particular application is the calibration range, says to Van Est. "The FLIR P640 thermal imaging camera is calibrated to a minimum temperature of -40 °C. This is very important to allow accurate temperature measurements. Most freezers are kept at a temperature between -20 °C and -30 °C. However, even at temperatures just below the official calibration range, such as some exceptionally cold freezers that cool down their contents to -50 °C or even -60 °C, the FLIR P640 thermal imaging camera is still quite capable of visualizing insulation leaks."

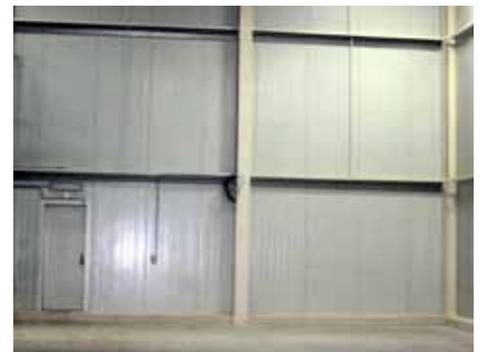
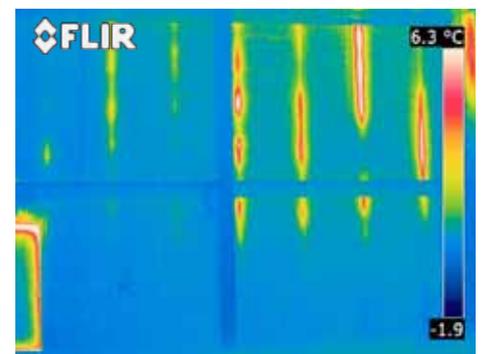
Improper welding has caused heat leakage in this section of the freezer insulation, as shown in this thermal image

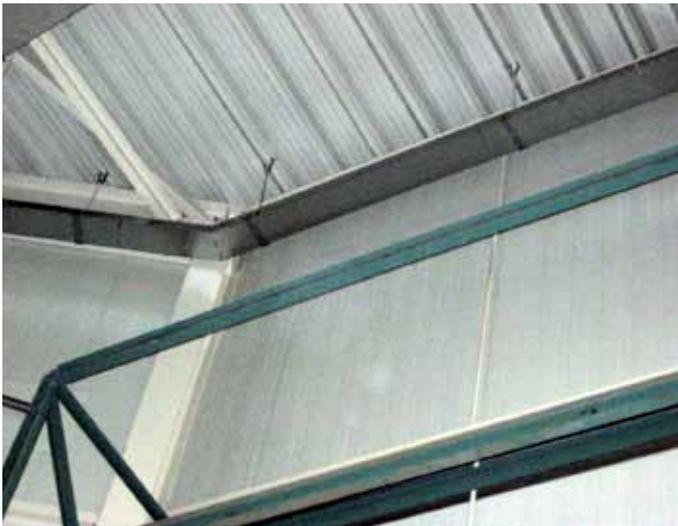
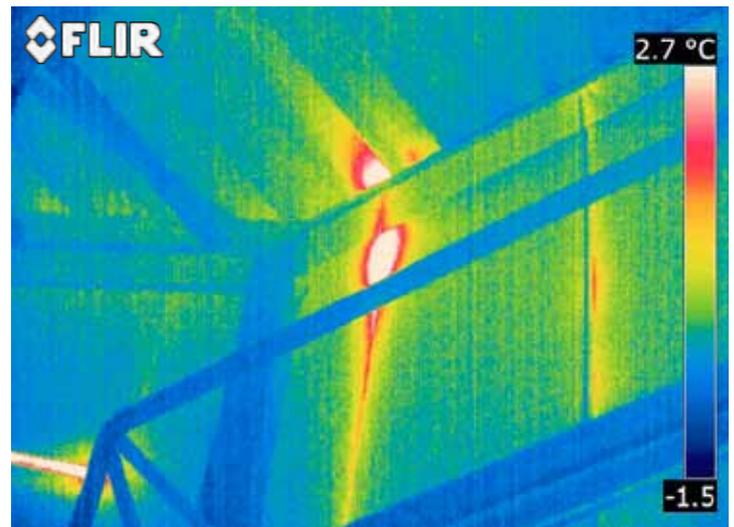
This thermal image shows an example of improperly connected joints between insulation panels, causing heat leakage.

newly built refrigeration units have a faulty construction. Sometimes the joints between the insulation panels are not protected properly, creating heat bridges. This can cause a lot of unnecessary energy consumption. In other cases older units might develop insulation faults over time due to wear. In both scenarios the best way to detect these insulation defects is by using thermal imaging cameras. Other methods, like spot pyrometers and such, really are not an option with this type of inspection. It is simply too easy to miss problems that you can relatively easily detect using thermal imaging."

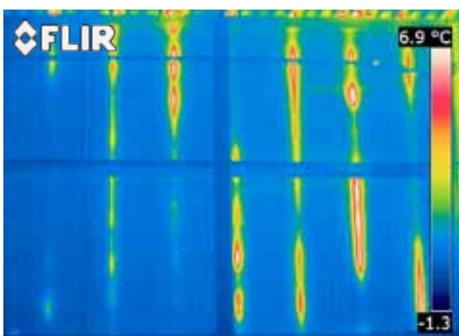
This thermal image shows heat leakage due to improperly connected joints between insulation panels, causing a lot of unnecessary energy consumption.
