The Västmanlands district main hospital, Västerås, Sweden

FLIR InfraCAM™ and E-Series infrared cameras save repair time and heating costs at hospital group

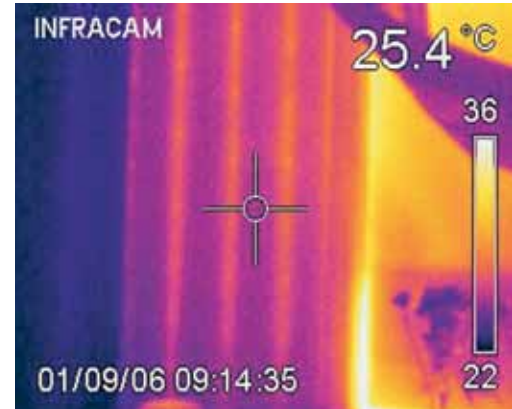
The image clearly shows were not to drill.

The infrared camera is also used by other contractors such as plumbers to look at water piping systems, especially prior to repair work, to be able to see where to drill (or not to drill), where (not) to break open floors or walls etc...Its use generates savings that are worth many times the price of a handheld infrared camera.

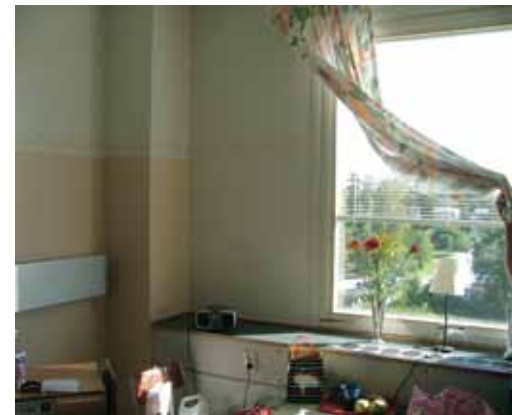
The camera easily detects leaks and moist areas, showing which areas are to be repaired in order to avoid further mold development.
