Ikaros Solar uses FLIR thermal imaging cameras to monitor installed solar

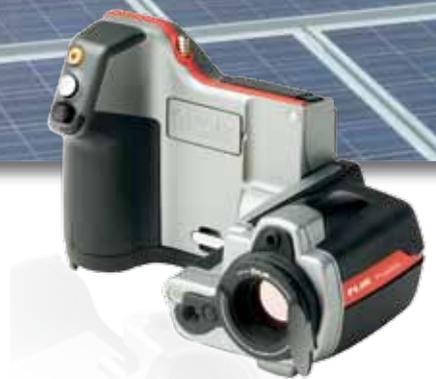
The ergonomic design and detailed high contrast thermal images make the FLIR T335 the perfect tool for solar panel inspections.

The camera of choice was the FLIR T335 thermal imaging camera. It has an uncooled microbolometer detector that produces crisp thermal images with a resolution of 320 x 240 pixels. It can accurately measure temperatures from -20°C to +650°C with a thermal sensitivity of less than 50 mK. Like all the FLIR T-Series thermal imaging cameras the FLIR T335 is very practical. The FLIR T-Series of portable thermal imaging cameras takes ergonomics, weight and ease-of-use to a new level. Usability is key: the engineers of FLIR Systems have translated user feedback on comfort and clarity into a series of comprehensive and innovative features.

"With the FLIR T335 it was much easier to spot small details", explains Kerremans. "And the T335 was also better designed, ergonomically shaped. Especially the tiltable lens unit is a great advantage. It allows you to look at the solar panel from just about every angle possible. That's especially useful if you try to look at a solar panel from the back. With the other cameras you had to lie down to be able to see on the screen what you were pointing the camera at. The FLIR T335 didn't have that problem, can effortlessly see where you are aiming the camera."

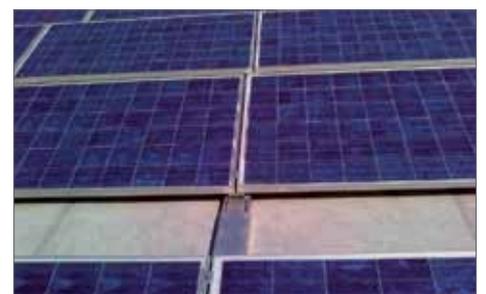
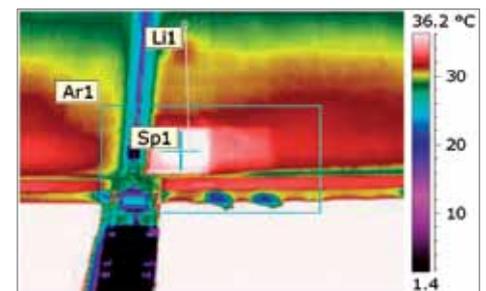
Faulty solar cells produce an excess of heat, making them easy to spot with thermal imaging technology.

Solar cells turn sunlight into electricity, but as they do so they also produce heat. Ineffective cells produce much more heat so the ineffective cells clearly show up as a hot spot on a thermal image.

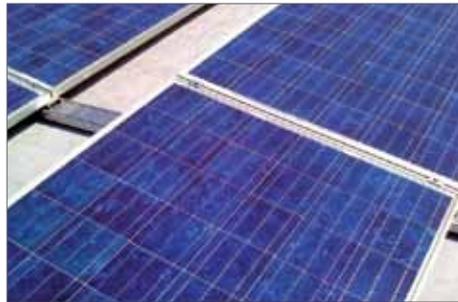
With a thermal imaging camera you can quickly locate issues such as this damaged cell, so the problem can be solved promptly.

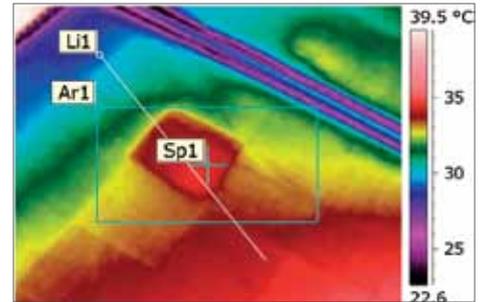
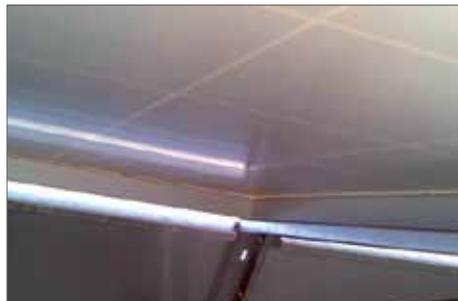
The tiltable lens unit of the FLIR T335 thermal imaging camera allows Kerremans to take thermal images from the back side of the panels, to avoid false 'hot spots' caused by reflection.

Looking at the back of a solar panel can sometimes be advisable to avoid reflection, Kerremans explains. "The glass on the front reflects thermal radiation, so if you're not careful your own reflection in the glass might show up as a hot spot in the thermal image. This can be avoided by carefully choosing the angle at which you point the camera towards the panel, but if you want to avoid the issue of reflection altogether you can also look at the panel from the other side. Because this side is usually hardly reflective at all you can be quite certain that the temperature measured by the thermal imaging camera is the actual temperature of that part of the panel!"

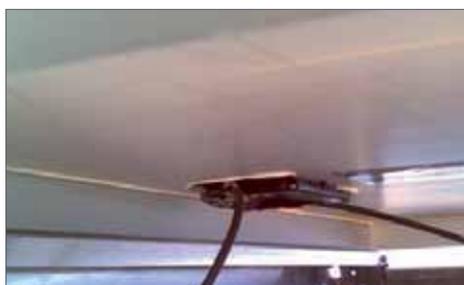
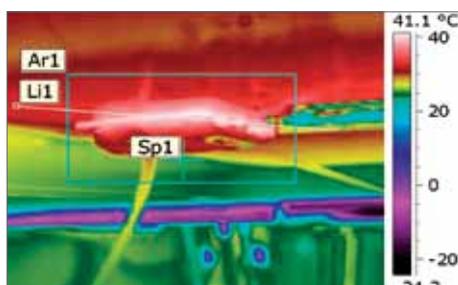
The FLIR T335 thermal imaging camera can also be used to scan the other components of the solar installation, such as this faulty connector.

But the FLIR T335 can do much more than solar panel inspections alone. "It is also very useful for the maintenance of the rest of the circuit. Just to illustrate: when we had just received the camera I tested it by looking at the electric connectors in one of our solar plants. I immediately spotted

two contacts that were hot and needed to be replaced."
