FLIR thermal imaging cameras help determine road conditions in Finland

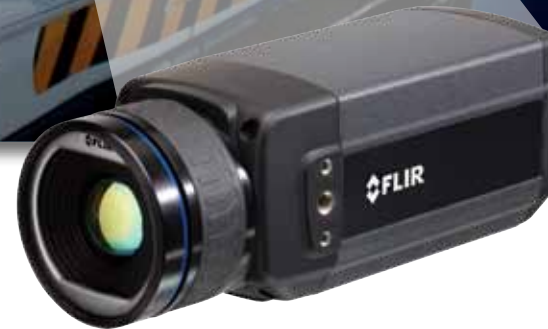
The high resolution, interchangeable optics and GigE connectivity make the A615 the perfect thermal imaging camera for the Road Doctor system.

FLIR A615

Resolution 640 × 480 pixels

Image frequency 50 Hz
(100/200 Hz with windowing)

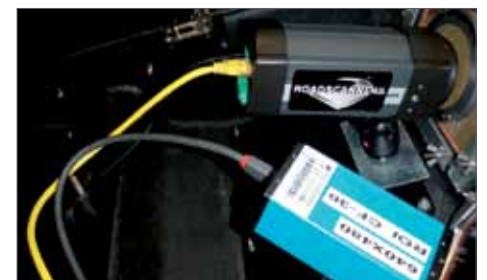
The Road Doctor diagnostics top box contains both a FLIR A-Series thermal imaging cameras and a digital video camera.

The thermal imaging camera is mounted on top of the Roadscanners' diagnostic vehicle. Currently FLIR A315 thermal imaging cameras are being used, but a switch to the FLIR A615 is being considered.

To be able to cover the entire road, a wide angle lens with 90° Field of View (FoV) is used. The data collected by the visible light camera, the Ground Penetrating Radar (GPR) and the thermal imaging camera are combined and stamped with the GPS location to enable accurate mapping of the problem areas that will need repair.

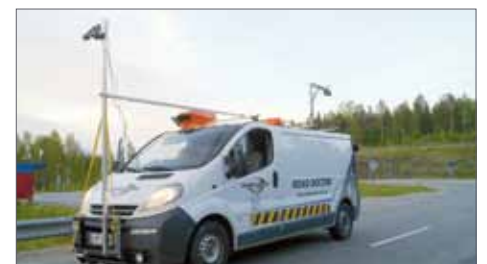
This special setup to check bridges includes an A-Series camera with a 90° wide angle lens attached to the front pole and a laser scanner on the rear pole.

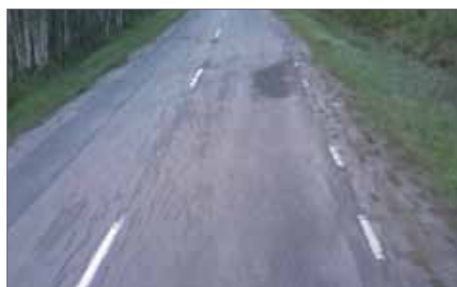
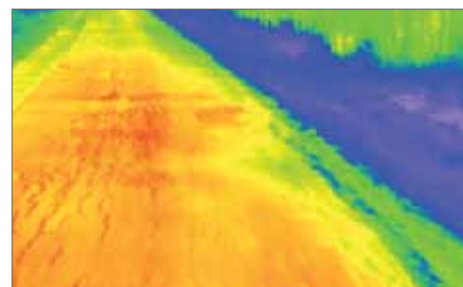
Thermal images taken in late spring are extremely valuable for road repair teams, because they show the location of the thawing ice in the underlying road structure.

"With a thermal imaging camera from FLIR you can find water ingress in the road surface that is invisible to the human eye", explains Saarenketo. "If water has entered the road structure it changes the way the road heats up or cools down. So in the dusk hours of the morning and evening the patches of road that contain water will show up in the thermal image. This information can be used to predict when that section of road will need repair. And the same concept also applies to bridges, where good water insulation is crucial for the lifetime of the concrete deck."

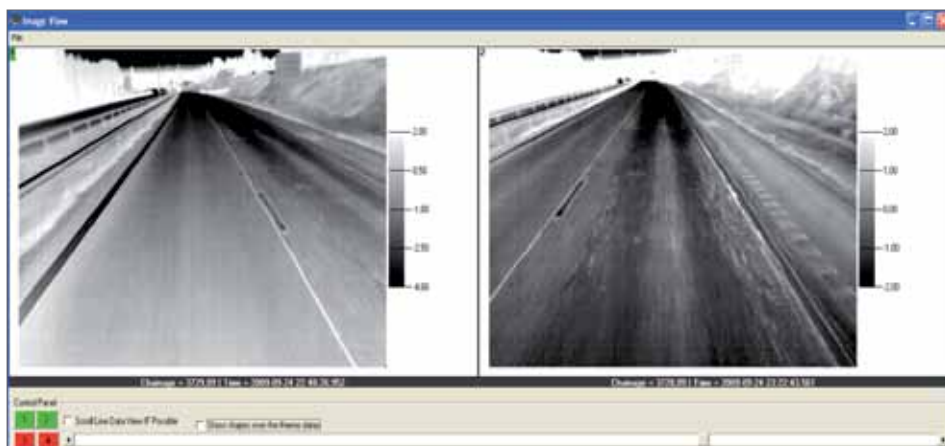
Good quality pavement (figure on left) provides a very homogenous thermal image while the thermal image to the right shows signs of cracks and water ingress in the asphalt.
