Solartechnik Stiens uses FLIR thermal imaging cameras to make sure their solar panels operate properly

FLIR T335 thermal imaging camera: usability is key

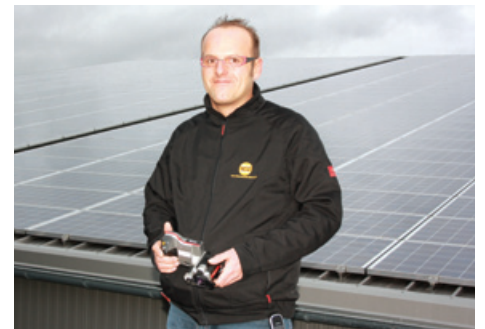
The FLIR T335 thermal imaging camera: light, compact and easy to use.

The FLIR T335 thermal imaging camera has an uncooled microbolometer detector that produces crisp thermal images with

a resolution of 320 x 240 pixels. It can accurately measure temperatures from -20°C to $+650^{\circ}\text{C}$ at a thermal accuracy of less than 50 mK. "The quality of the images the FLIR T335 thermal imaging camera produces is remarkable, but even more important for our application is the practical design", explains Mr. Kimpel. "Especially the fact that it is lightweight and that it has a tiltable lens unit makes it the ideal tool for fieldwork, checking already installed solar panels for flaws."

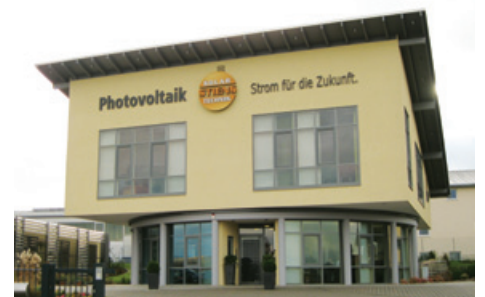
Every 10 minutes the upper story of the main office building of Solartechnik Stiens in Kaufungen moves almost imperceptibly, directing the solar panels on the roof toward the sun.

follows the course of the sun. Every 10 minutes the upper story of the office building moves almost imperceptibly. It turns 180° from sunrise to sunset, directing the solar panels toward the sun throughout the sunshine hours, thus making optimum use of the power of the sun.

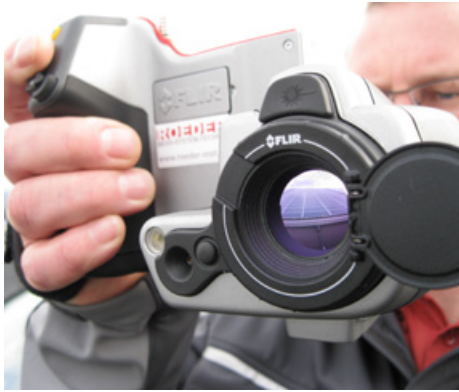
The FLIR T335 thermal imaging camera is available with several different interchangeable lenses.

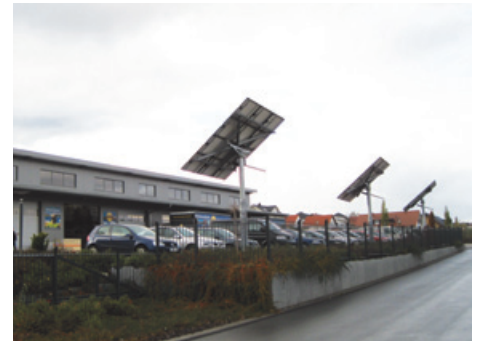
These solar panels that are mounted on poles can be scanned from the back to minimize reflection.

The best way to solve this problem is to avoid reflection altogether. “It’s not always an option in solar panels that have been installed on a roof, but with the solar panels on the parking lot of Solartechnik Stiens that are mounted on poles it is possible

to take a thermal imaging camera and point it at the back of the solar panel. The back of the panel doesn’t reflect thermal radiation as much, so you can more accurately measure the temperature of the solar panel.”

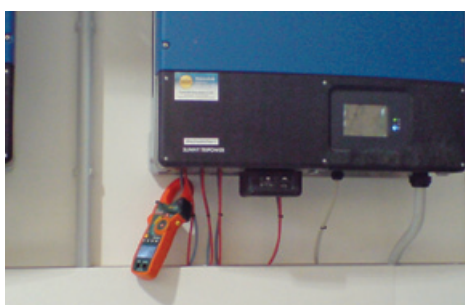
These inverters convert the direct current from the solar panels to alternating current.

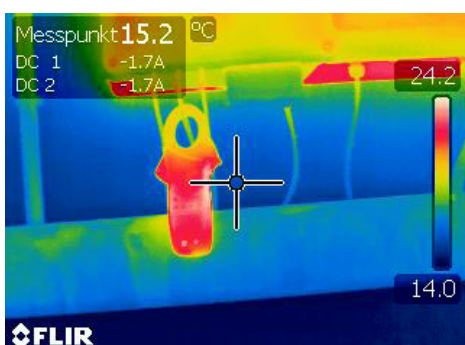
FLIR MeterLink technology allows the measurement data collected with the clamp meter to be transferred via Bluetooth and combined with the thermal image.

an Extech clamp meter, because it can be connected to the FLIR T335 thermal imaging camera through a MeterLink connection. FLIR MeterLink technology simplifies the work in electrical or building inspections by making it possible to transfer the measurement data of the clamp meter via Bluetooth to the FLIR thermal imaging camera. This saves time and eliminates the risk of erroneous records or notes. "Before we could connect the FLIR T335 thermal imaging camera with the clamp meter via MeterLink we had to manually write down the measurement values of the clamp meter in our notebook. With FLIR MeterLink that information is automatically combined in one report."

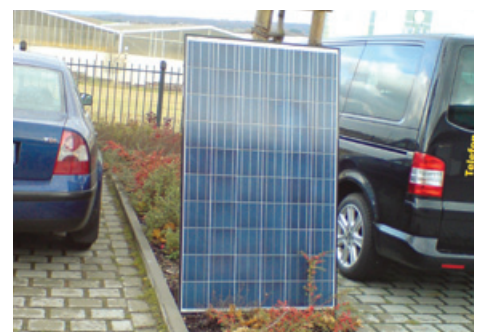
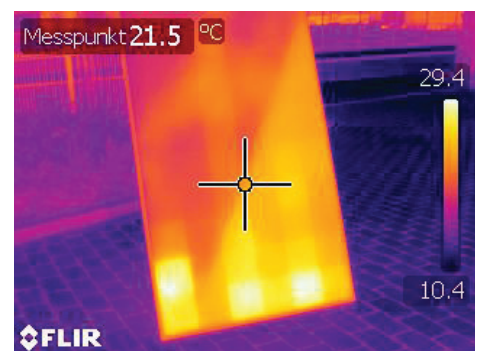
A test with a solar panel in the parking lot of Solartechnik Stiens shows that the hot spots can quite easily be seen on the thermal image, even from the front.

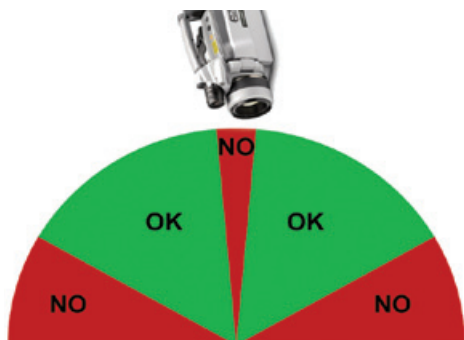
Viewing angle recommended (green) and to be avoided (red) during thermographic inspections.

According to FLIR Area Distribution Manager Michael Mende the viewing angle should be chosen carefully to avoid misinterpretation of thermal images due to heat emitted by surrounding objects that are reflected in the glass. “Pointing the thermal imaging camera at the solar panel perpendicularly would provide the best result, because emissivity is at its highest when the angle is perpendicular, and decreases with an increasing angle, but in the case of a perpendicular angle the reflection of the camera and the operator might be seen in the thermal image. Therefore a viewing angle of 5–60° (where 0° is perpendicular) is seen as a good compromise.”

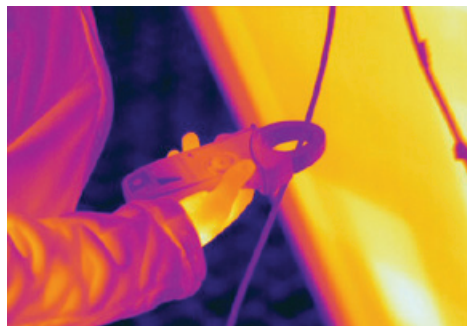
The amount of electricity the panel produces can quite easily be measured with the clamp meter. The measurement data are combined with the thermal image with the help of FLIR MeterLink technology.

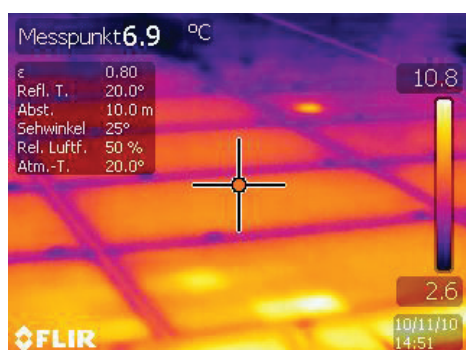
The Picture-in-Picture feature allows the user to overlay the thermal image directly over the corresponding visible image. At the push of a button the user can simply move, resize, and reshape thermal images inside the visual image.

These two features of the FLIR T335 make it easy to create compelling reports and communicate trouble spots to colleagues or clients. The Picture-in-Picture feature allows the user to overlay the thermal image directly over the corresponding visible image taken with the integrated 3.1 megapixel photo camera. This functionality combines the benefits of both the infrared image and visual picture at the push of a button. The user can simply move, resize, and reshape thermal images inside the visual image.

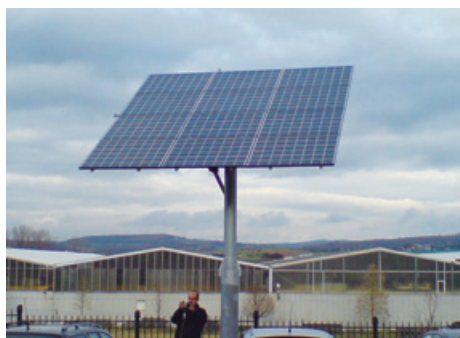
The hot spots on this thermal image taken from the front of the solar panel might seem to indicate that a multitude of cells are working inefficiently.

thermal imaging camera to look at solar panels from the front side then you have to be very careful not to jump to false conclusions due to reflection.”

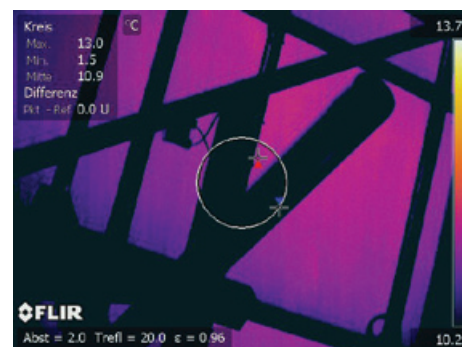
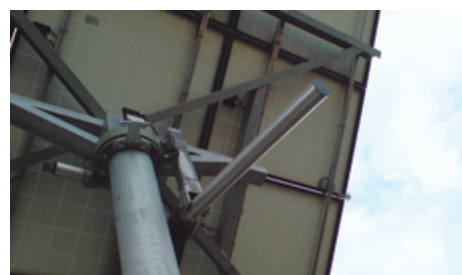
Inspection from the back shows no hot spots, the hot spots in the previous thermal image taken from the front were caused by reflection.

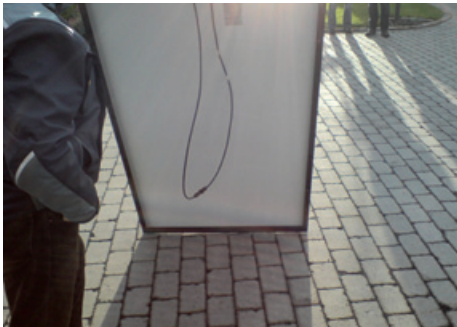
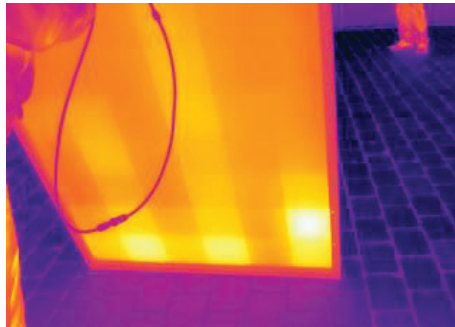
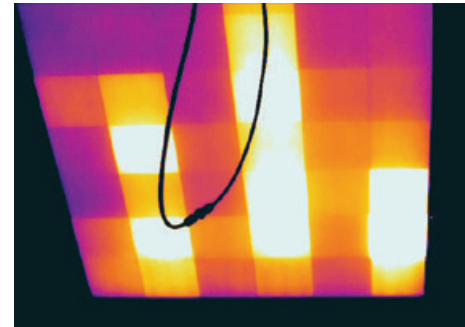
These images taken from the back of the same solar panel show much less reflection than the front, making the temperature measurements much more accurate.

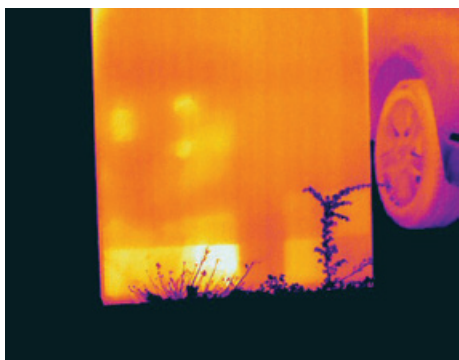
These hot spots seem to indicate inefficient solar cells, but closer inspection shows that several of the hot spots are caused by the reflected warmth of people standing in front of the panel.

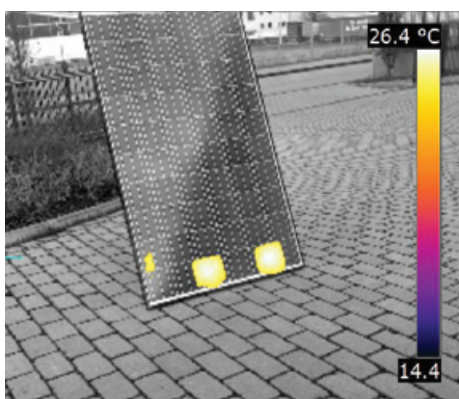
In this Thermal Fusion recording only the hot spots on the thermal image are shown.

integration of the visible photo and thermal image one step further. It allows certain temperature ranges of the thermal image, for instance by showing only the hot spots.

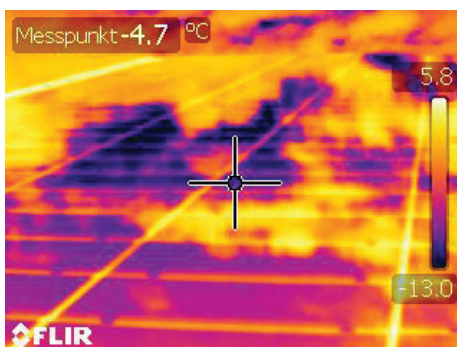
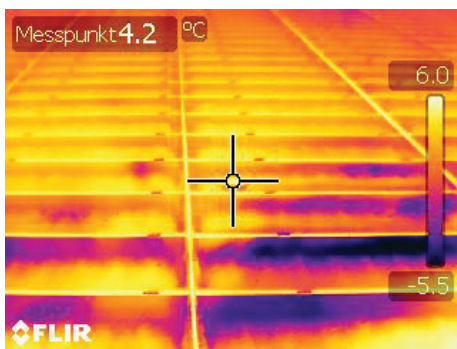
This thermal image quite clearly shows that reflection can pose a problem when monitoring solar panels: the thermal imaging camera records the reflected thermal image of the cloud instead of measuring the temperature of the panel itself.
