The Neustadt Bayernoil refinery

A FLIR INFRARED FURNACE CAMERA FOR HIGH TEMP INDUSTRIAL APPLICATIONS WATCHES HYDRO REFORMERS AT GERMAN BAYERNOIL REFINERY COMPLEX

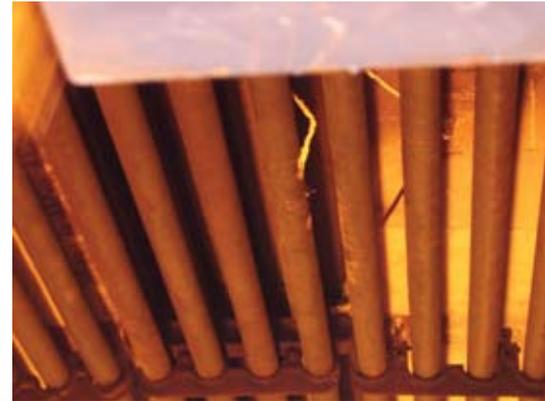
Visual and IR image of inner furnace piping: Mk2 shows a temp sensor fastener, not a hot spot cab le
